ERDC/CHL TR-00-1

Coastal and Hydraulics Laboratory

## **Demonstration Erosion Control Project Monitoring Program**

### **Fiscal Year 1995 Report**

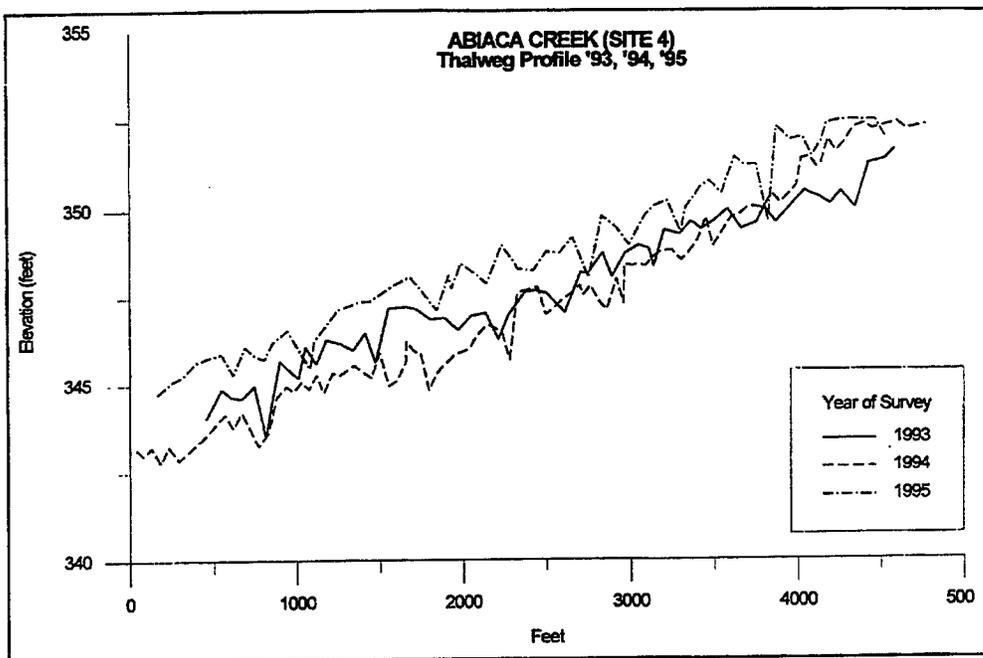
Figure 11. Thalweg profiles for Abiaca Creek, site #4

Site No. 4 is on Abiaca Creek and extends approximately 4,000 feet upstream from the confluence of Coila Creek as shown on Figure 10. This site is located in T17N, R2E, Section 4 and has a watershed area of approximately 44 square miles. This site is located approximately 1.8 miles downstream of a major sand and gravel processing operation that can be associated with increased supply of suspended and bed material load. Stream banks in this reach are relatively stable except as the channel impinges on high bluffs. The bed has fluctuated with a general aggradation for the past four years, and is a mixed sand/gravel reach. With the low summer and fall discharges, vegetation had encroached into the channel. No vegetation was observed to be permanently affecting the channel, and will be removed unless the low flow persists. See Table 3 for summary results and Figure 11 for thalweg profiles.

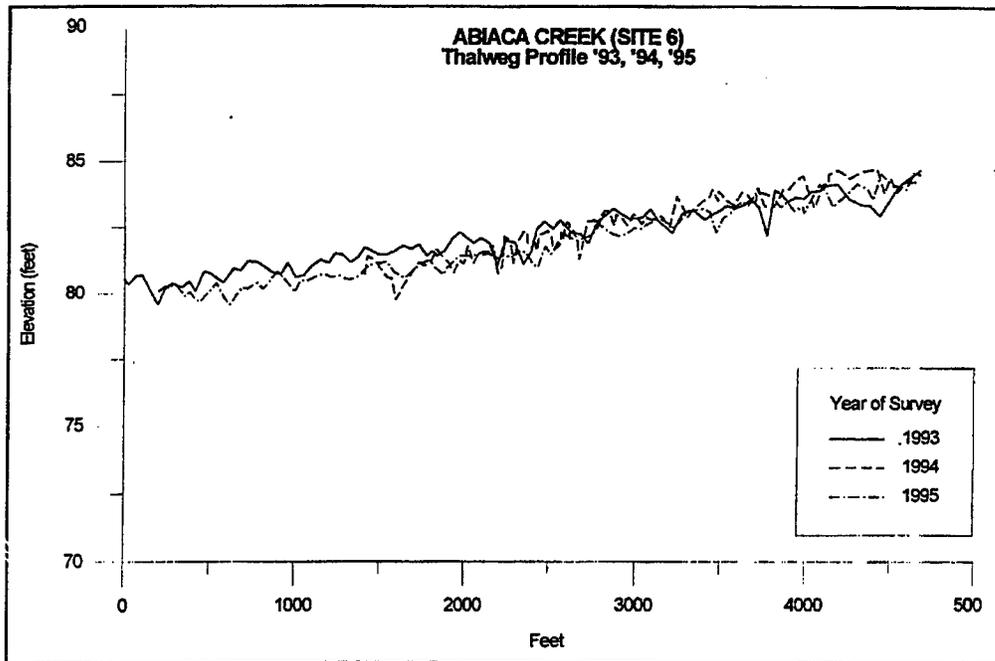
Figure 13. Thalweg profiles for Abiaca Creek, site #6

The thalweg profile and channel dimensions have been relatively constant since 1992. A project to construct a sediment trap at this site was observed to be under construction in 1995. Later monitoring results will be impacted by that construction. See Table 4 for summary results and Figure 13 for the thalweg profiles.

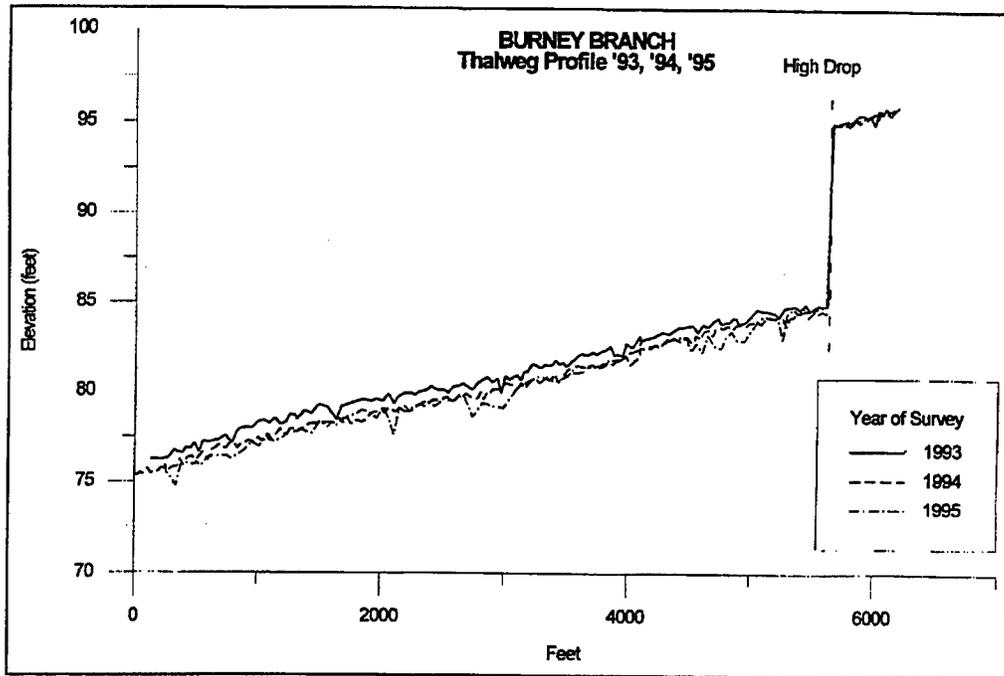
Figure 17. Thalweg profiles for Burney Branch, site #12

The two high-drop structures have been very successfully utilized in rehabilitating this reach of Burney Branch. Both structures were constructed in 1982 by the SCS, and the effects of the structures on the channel were surveyed and analyzed by Watson et al. (1984). These structures were designed to contain the 100-year discharge and include the provision for floodplain storage using valley dams in conjunction with each structure. The original design of the structures provided for a bed slope of 0.0008 between structures, based on Lane's tractive stress analysis. The 1984 surveyed bed slope was 0.0012, indicating that the upstream sediment yield was greater than planned. Since 1984, several major channel stabilization projects have been constructed upstream. Channel stabilization under conditions of decreasing sediment supply is a situation that will be faced as the success of the DEC programs are realized. Potentially, upstream stabilization can cause stability problems downstream.

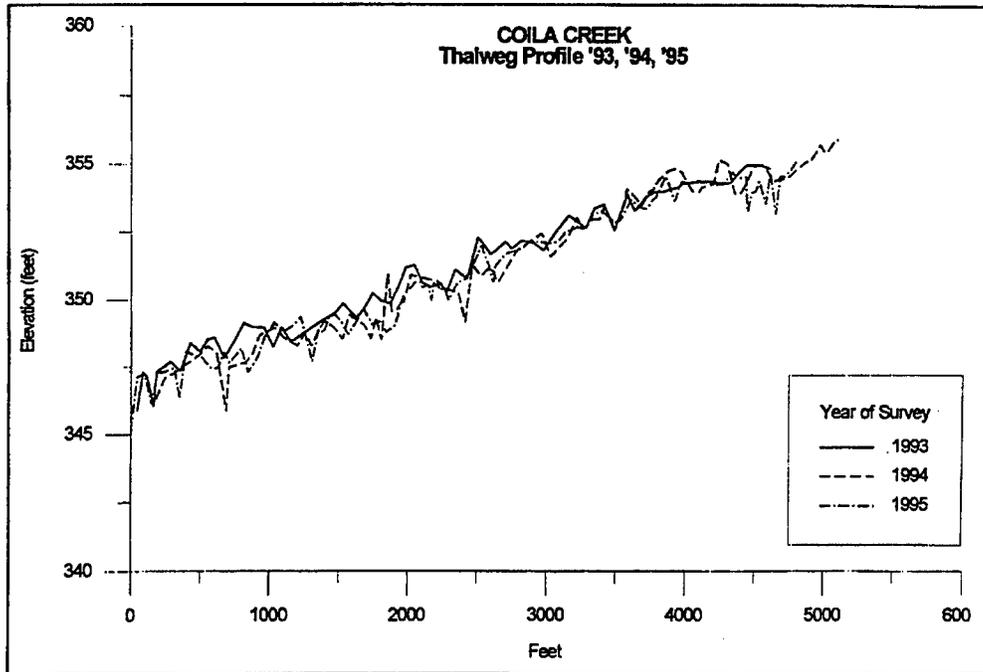
Figure 19. Thalweg profiles for Coila Creek, site #5

The reach thalweg profile has no significant trends, and the bank stability was poor only near the confluence with Abiaca Creek in a bendway. The  $D_{50}$  of the reach was sampled and analyzed to be 10 mm, which does not allow reliable SAM computations using the sand-bed based equations. The upper portion of the reach is has a very stable inner-channel with a gravel bed and overhanging riparian vegetation.

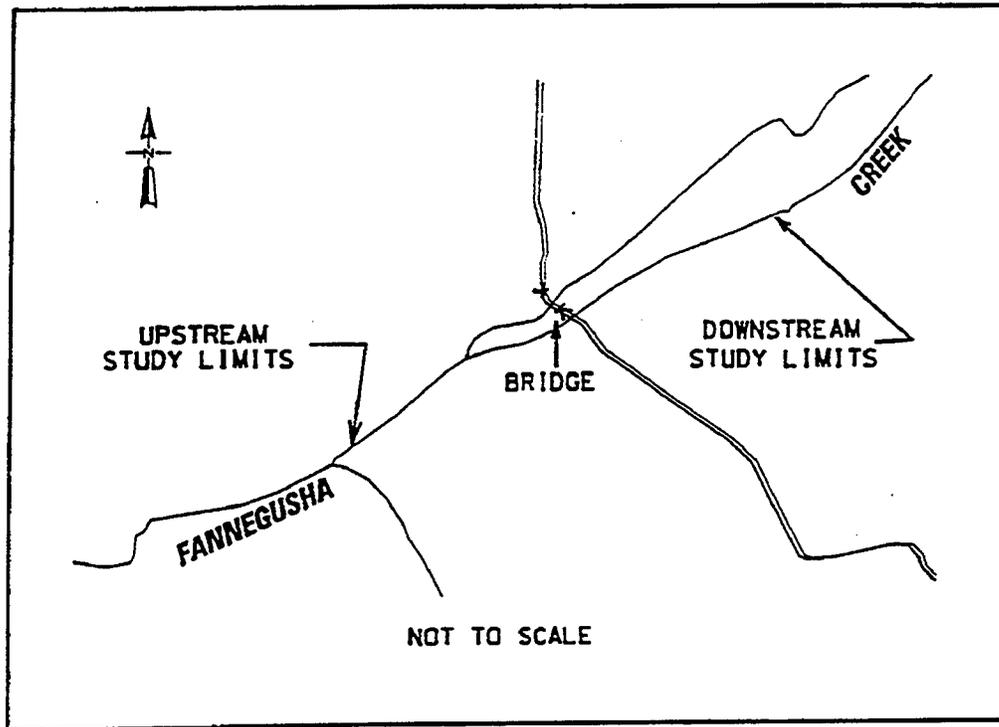
Figure 20. Fannegusha Creek, site #2

A low-drop structure was constructed in 1993 approximately 1500 feet downstream of the bridge. The stream bed appears to be aggrading for a distance of approximately 1500 to 2000 feet upstream of the structure. The bridge was replaced in 1994 due to earlier channel widening. Observations indicate that the channel will continue to widen as over-steepened banks continue to fail, due to previous bed

degradation.

Bed degradation upstream of the bridge will continue as a headcut progresses upstream. At present, the headcut is located approximately 1200 feet upstream of the bridge. Another grade control structure has constructed upstream of the study reach; however, the primary sediment supply to the reach may be entering the channel in a large left bank tributary that is near the upstream extent of the reach. An investigation of this tributary is recommended for the purpose of developing stabilization plans.

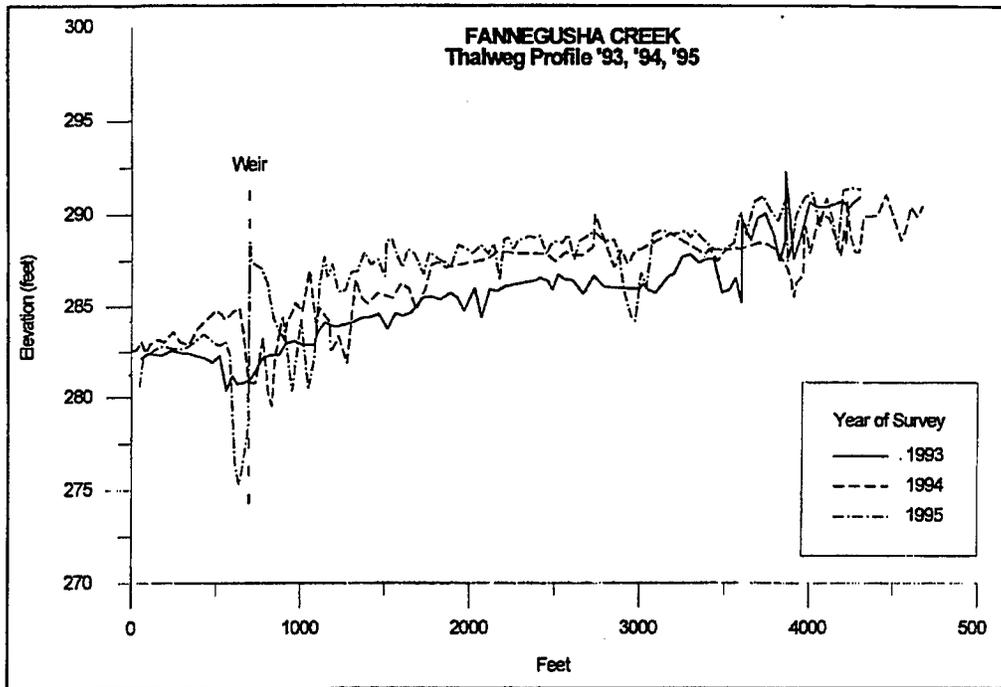
Figure 21. Thalweg profiles for Fannegusha Creek, site #2

BURBANK results (Table 8) indicated the banks are generally stable. The reach averaged SAM results portray a generally stable hydraulic condition; however, the channel response to the recently constructed grade control structure is very dynamic and continue upstream. Although the upstream portion of the study reach is a CEM 2, the overall reach has been classified CEM 4.

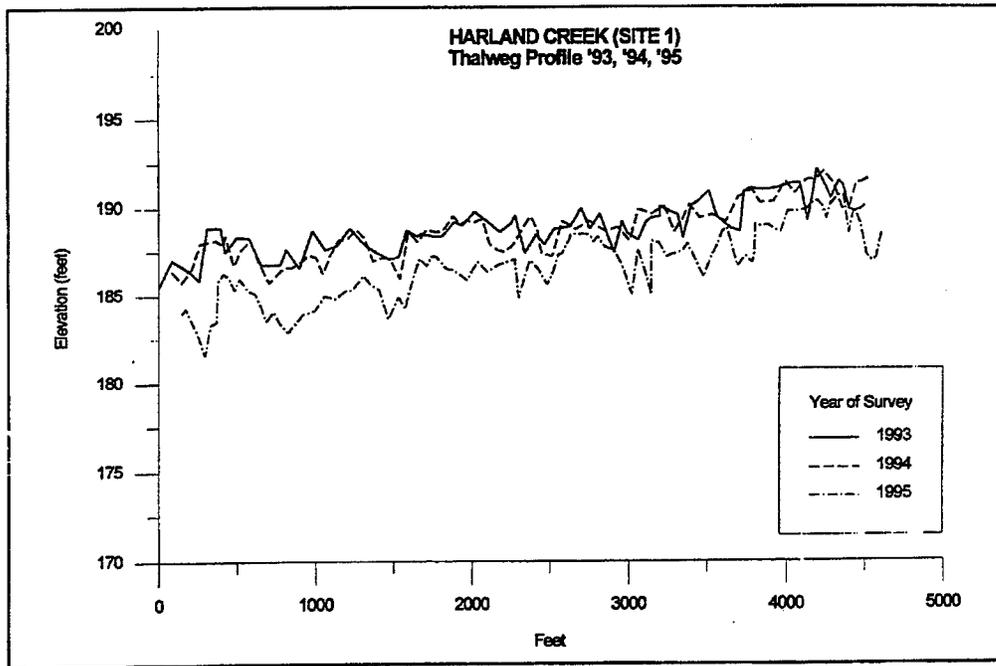
Figure 23. Thalweg profiles for Harland Creek, site #1

The thalweg profile (Figure 23) for the reach indicates a consistent degradation along the reach. Field evidence indicates that the reach has degraded, and significant bank erosion was noted. The longitudinal riprap placed in the lower 2000 feet of the reach experience minor launching, and no bank instability was noted along the riprap. The upstream, unprotected, portion of the reach had severe and consistent bank erosion, demonstrating the effectiveness of the downstream riprap. Additional bank stabilization for Harland Creek should be considered. A short gap in protection on the left bank downstream of the left bank tributary should be considered for construction.

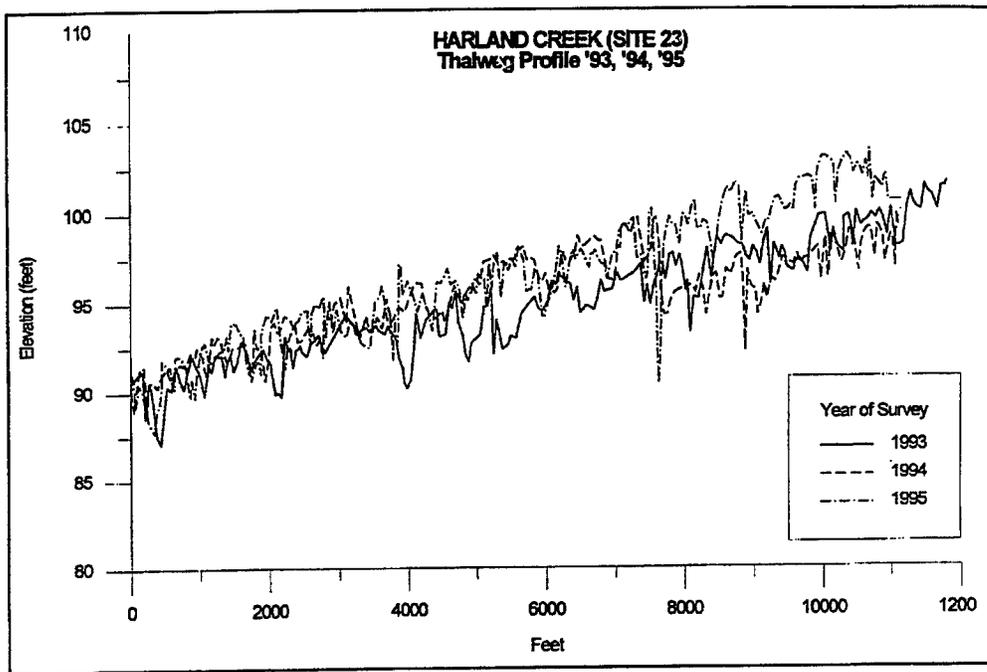
Figure 25. Thalweg profiles for Harland Creek, site #23

As shown in the thalweg profile, Figure 25, the primary difference between the

Large gravel bars were observed in the field inspection of October, 1994. Some of these bars were in atypical positions for a meandering stream, indicating that the deposits occurred during the recession of a major flood event. It is expected that lower flows will continue to re-work these deposits. Two additional factors that may contribute to the aggradation is the degradation of the upstream site, and the increased roughness caused by the bendway weirs and the willow posts.

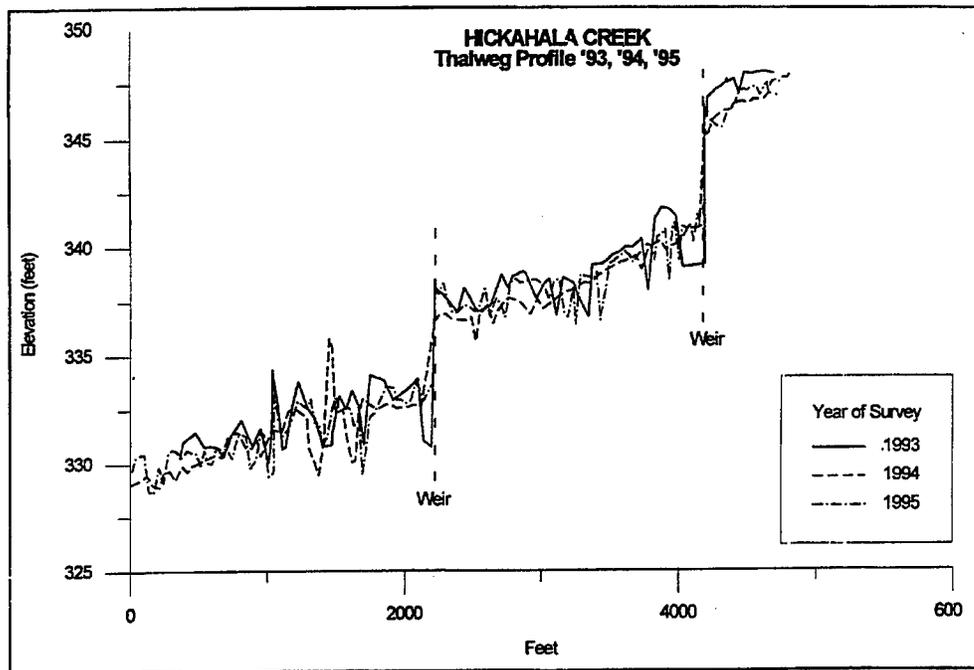
Figure 27. Thalweg profiles for Hickahala Creek, site #11

The downstream portion, Segment 1, is not influenced by a downstream grade control, although County bridge construction at the time of the last inspection may provide some control. The bed of Segment 1 is the erosion resistant clay commonly found at knickzones, and has been classified as CEM 2. The thalweg profile indicates that the bed is eroding very slowly (Figure 27). Some filling was observed in Segment 2 as a result of the downstream grade control structure.

SAM results indicate that hydraulic slope is continuing to increase and to narrow, and BURBANK results indicate that the banks are stable for the conditions tested for Segments 1 and 2 (Table 11). Segment 2 should continue to respond to the structure with filling in the lower and middle portion of the segment, and the upper portion may degrade at the upstream structure lower apron. Segment 1 will continue to slowly erode until the clay material is breached, at which time headcutting will resume. At the time of the last inspection, an active headcut was observed in the upper portion of Segment 1.

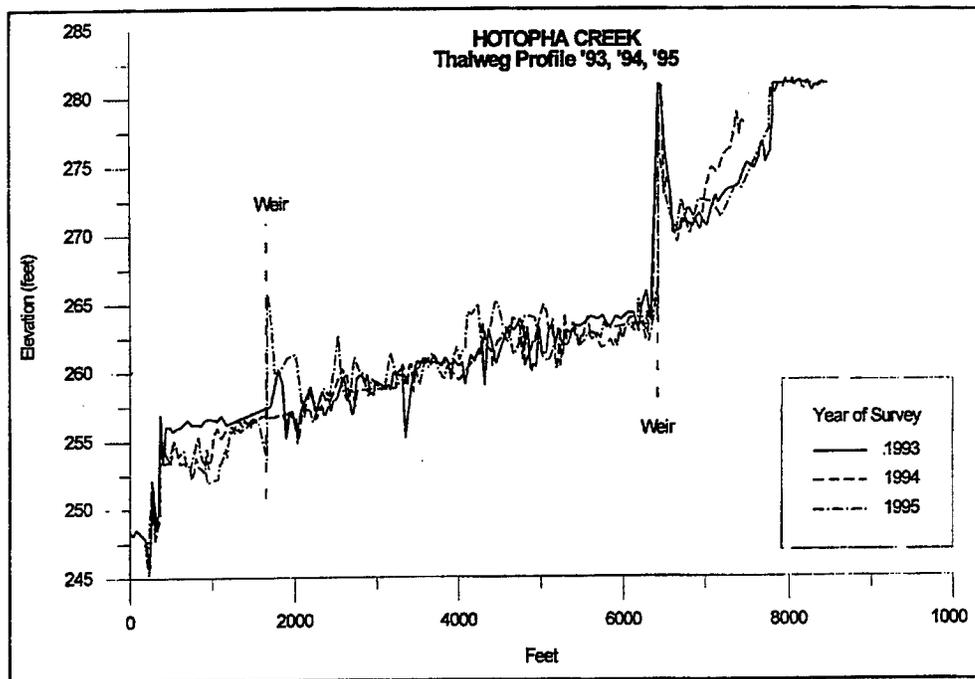
Figure 29. Thalweg profiles for Hotopha Creek, Site #13

The thalweg profile, Figure 29, indicates that degradation is occurring in Segment 1, and is moving upstream to the downstream high drop. This incision is in response to sediment storage in the upstream structures. The surveyed profile indicates that some filling has occurred in Segment 2, and that very little filling occurred in segment 1. The three high drop structures and the upstream drop box culvert have provided massive sediment storage and pooling of water, and the response to these structures will occur slowly. The pools upstream of the high drop may persist for several years, and biological sampling could document the changes in habitat as the pools evolve.

All three segment have been classified as unstable, and each segment is ponder by the downstream structure. Segment 1 is degrading in response to the reduction in upstream sediment supply, and segments 2 and 3 are filling slowly. No CEM classification was made due to ponding, which was not a condition envisioned in the original model. The SAM calculation of the sediment transport capacity for Segment 1 is 3.5 times the capacity for Segment 2, and Segment is 1.6 times the Segment 2 capacity. Therefore, Segment 1 will degrade and Segment 2 will continue to aggrade if sediment supply is available. BURBANK results indicate bank instability can be expected, especially if the zero friction angle assumption occurs (Table 12).

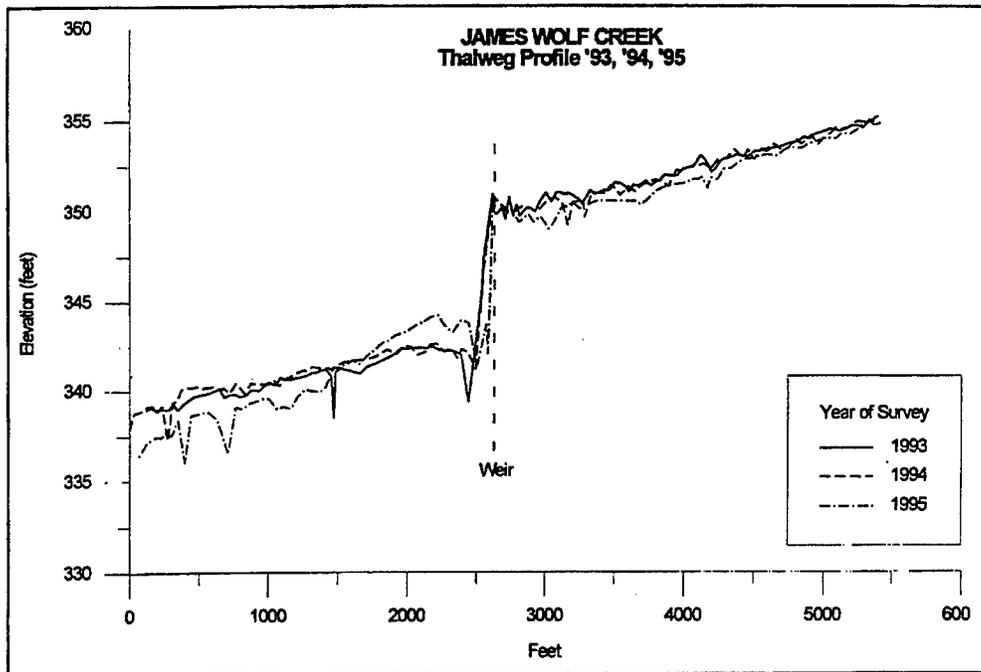
Figure 31. Thalweg profiles for James Wolf Creek, site #19

The thalweg profile indicates that both segments degraded on the order of 1 to 2

feet (Figure 31). Sediment transport capacity in the range of 3000 mg/l and the channel slope, 0.0017, are approximately the same for both segments. BURBANK results based on surveys prior to the longitudinal riprap emplacement indicate that Segment 1 banks are 100% at risk, and that Segment 2, upstream of the structure, are 50% to 60% at risk. The Segment 1 bank stabilization should improve stability. SAM results indicate that the channel is relatively steep and wide at the 2-year discharge (Table 13).

Rebuilding the drop structure and downstream longitudinal riprap improves the stability of this system. Kudzu will continue to dominant the vegetation, restricting development of more desirable vegetation that could improve bank stability and increase roughness. However, channel response is slow and the rate of change is dependent on upstream sediment supply.

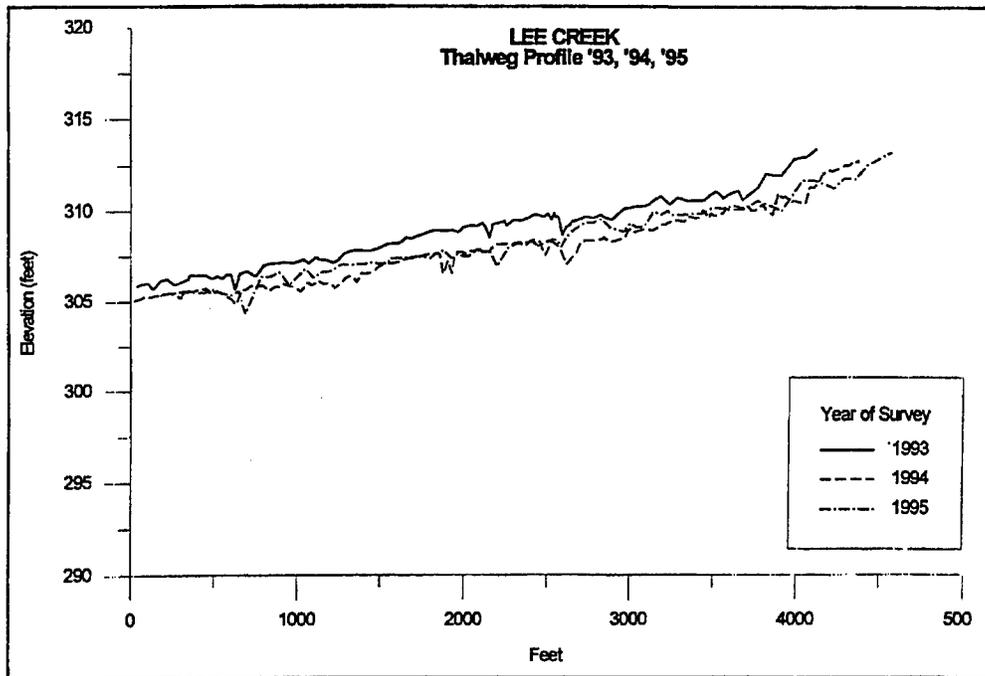
Figure 33. Thalweg profiles for Lee Creek, site #10

BURBANK results indicate confirm that the banks are stable. SAM results indicate that the slope has changed little since 1993, however, average width is decreasing due to upstream loss of conveyance (Table 14).

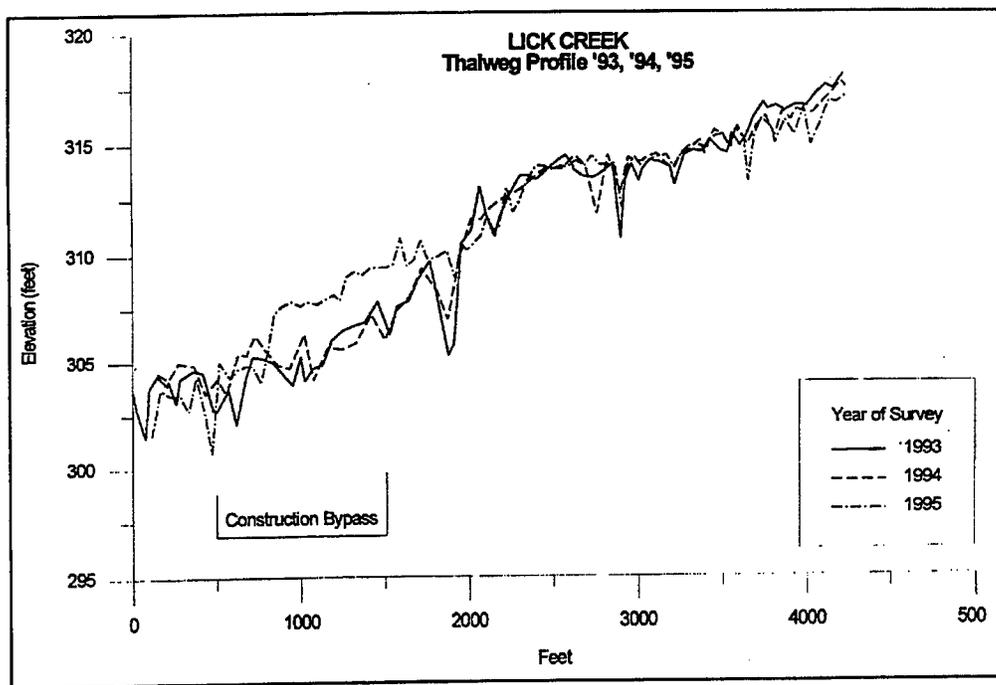
Figure 35. Thalweg profiles for Lick Creek, site #8

A high-drop structure was under construction at the time of the November, 1994 field inspection, and is located at approximate station 18+00 of the accompanying thalweg profile, Figure 35. The construction was not complete at the time of the January, 1995 survey, and the survey was made through the construction bypass as indicated in the figure. As shown on the thalweg profile, the riprap placed at the bridge (Station 20+00) as a temporary measure has helped to slow the incision that is continuing upstream and downstream of the bridge. Degradation is continuing downstream of the structure and can be expected to continue after the closure of the structure. The backwater of the structure should assist in halting the upstream incision if the knick zones have not progress too far upstream to be affected by the high drop. The high drop will protect the highway bridge. In general, the Lick Creek site is a CEM type 3 downstream and through the bridge, is a type 2 at the upper extent of the site. Presently, the upstream extent of the site is incising into resistant clay (Table 15).

The SAM analysis indicates that the slope width has been increasing. BURBANK analyses indicates that three feet of additional degradation will destabilize 50% of the Segment 1 surveyed banks and 12% of the Segment 2 surveyed banks with the assumption of zero friction angle. Left bank drainage upstream of the bridge is poor, with standing water in the adjacent field. Channel incision and a saturated left bank may combine to result in greater instability than in other similar streams. A drop pipe could be added to improve bank drainage. The high drop structure will improve the stability of the upstream channel reach, and it will be of interest to observe the upstream and downstream channel response following construction completion (Table 15).

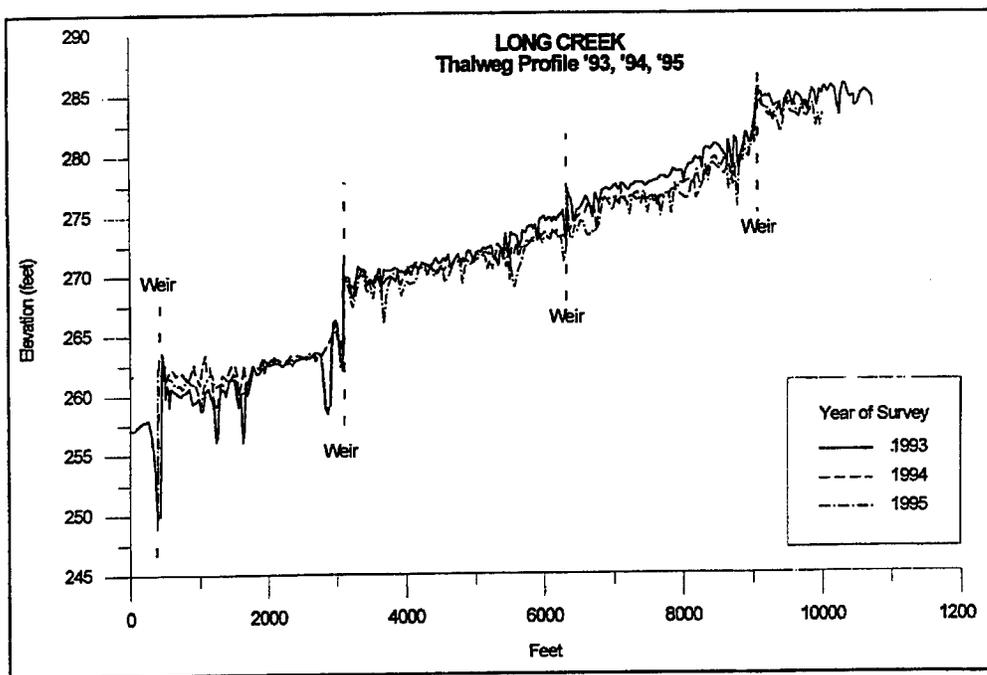
Figure 37. Thalweg profiles for Long Creek, site #20

Long Creek is divided into four segments: at station 0+00 at the fourth downstream drop structure; at approximate station 32+00 at the older low drop structure; at approximate station 68+00 at the next upstream low drop structure; and at approximate station 90+00 at the upstream weir. Figure 37 shows a thalweg profile of Long Creek. Segment 1 aggradation occurred in the period from completion of the lower drop in 1993 through the 1994 survey, and minor degradation occurred in 1994. Significant thalweg change is within 300 feet downstream of the upper weir. At this location, headcutting is moving into the weir. Numerous beaver dams that are present in segments 2, 3, and 4.

BURBANK analyses shows the significant improvement in bank stability moving upstream from Segment 1 at 33% to 0% in Segment 4. Without structural control, degradation would be continuing and the effects of 3 feet of degradation indicated in the tabulation are from 100% in Segment 1 to 6% in segment 4, which demonstrates one of the positive aspects of low drop grade control (Table 16).

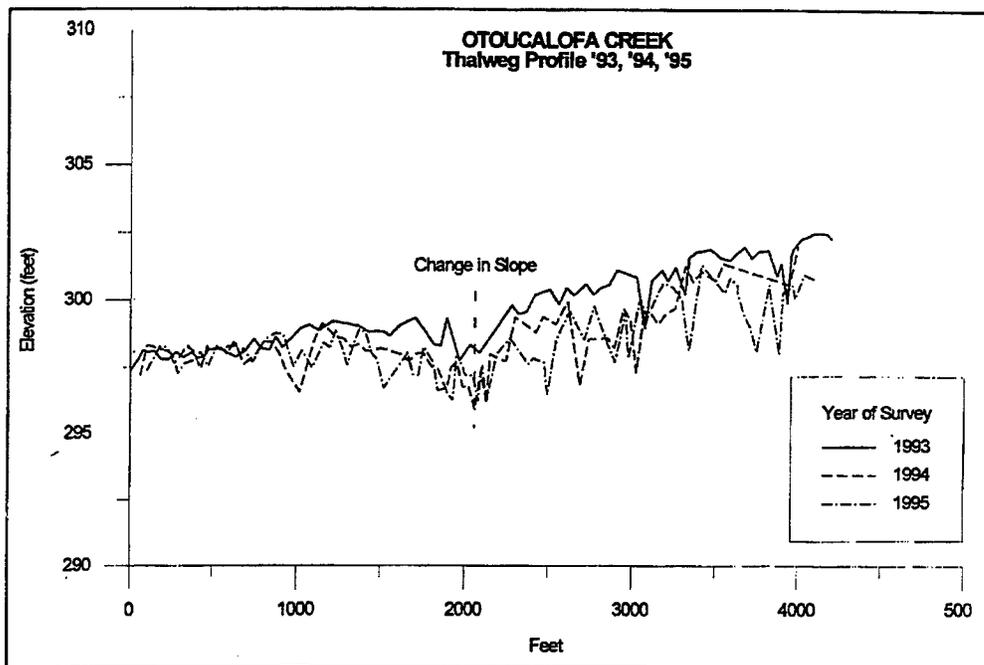
Figure 41. Thalweg profiles for Otoucalofa Creek, site #14

Presently, only riprap dikes and longitudinal dikes are constructed throughout the reach. The reach was observed to be actively incising in 1994 and this incision is occurring at an elevation below the recently placed stone. This site provided a unique opportunity to observe the riprap subjected to severe degradation, and some of the stone placed in the upstream Segment 2 has launched and was no longer visible during the November, 1995 inspection.

BURBANK results indicate that the banks are stable, and SAM results are generally consistent with the CEM 3 designation given.

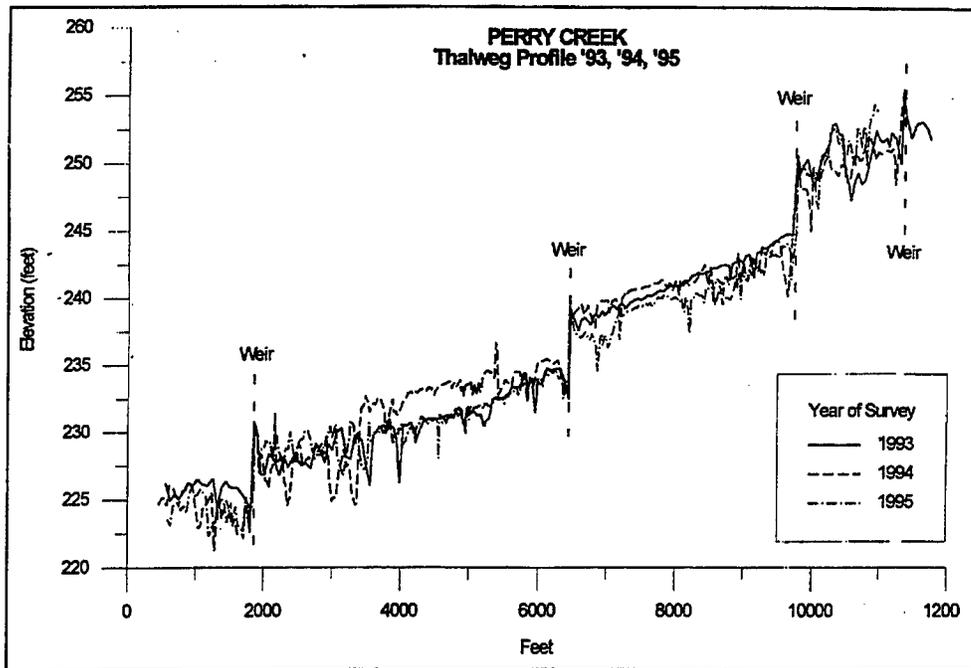
Figure 43. Thalweg profiles for Perry Creek, site #16

Downstream of the lower grade control structure, Segment 1, is ponded as a result of a downstream shale outcrop. The extent and durability of the shale is unknown, and failure of the existing headcut will result in 2 to 3 feet of degradation moving into the structure (Perry #3). Upstream of this structure, the channel is ponded. Segments 1 and 2 transport less than 1000 mg/l. Segment 3 is responding to the structure (Perry #4) and some incision is continuing upstream. A gully on the left bank approximately 500 feet downstream of Perry #5 should be considered for a drop pipe. Although the slope in Segment 4 is very steep, the bed is relatively erosion resistant ironstone and may respond slowly.

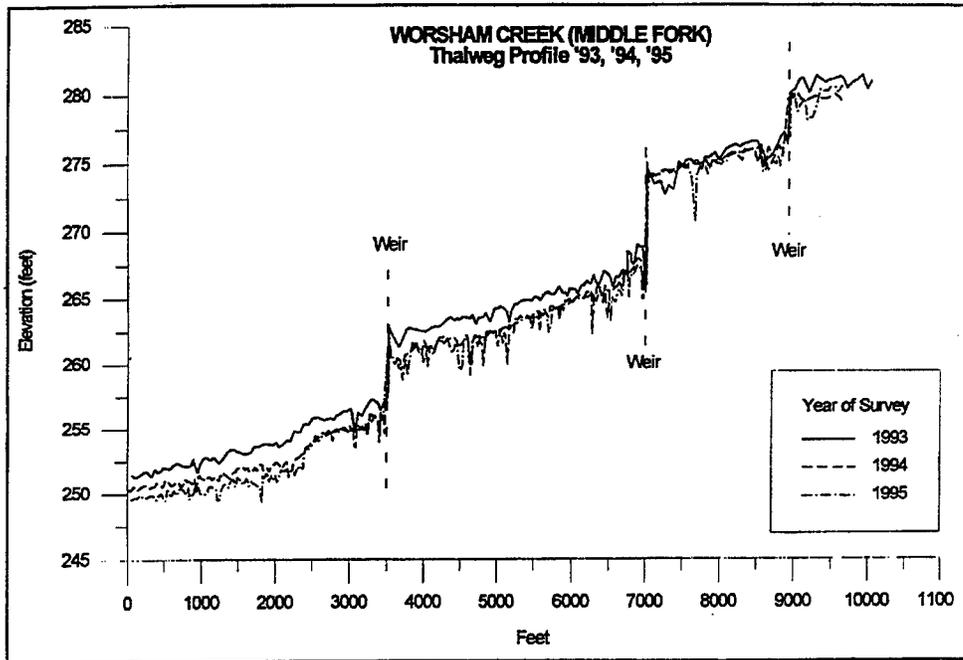
Figure 52. Thalweg profiles for Middle Worsham Creek, site 18b

The downstream extent of Middle Worsham is at the confluence with West Worsham Creek. The total reach is approximately 10,000 feet in length and is divided into four reaches by three ARS-type, low drop structures. See Table 23 for summary results and Figure 52 for thalweg profiles. The accompanying thalweg profile, Figure 52, depicts the degradation that has occurred since 1992 in the lower two segments. The primary location of degradation during the 1994-1995 period was the downstream portion of Segment 1. The table of BURBANK results clearly shows the value of the grade control structures in reducing or maintaining low bank height. Percentage of

bank height unstable for the zero friction angle decreased from 67% in the lower reach to only 3% for the upstream reach. Unfortunately, in the lower reach with no grade control, the percentage of bank unstable will increase as the channel degrades. Minor degradation is continuing at the upstream extent of Segment 2, and incision was observed in the field at Segments 1 and 2. Sediment has filled to the crest of the structure in Segment 3.

Immediately upstream of the confluence of West and Middle Worsham, Segment 1 has a shallow depth of sand, less than 2 feet, for most of segment up to the confluence with East Worsham. Upstream of this confluence, the channel is narrower and nick zones are present. Two drop pipes had been cleared for surveying in 1994 and were not constructed in 1995 in this reach. Again in Segment 2, as the upstream structure is approached nick zones are present and massive bank failures are present. Headcutting in the upstream portion of Segment 3 is moving into the older structure at a slow rate, and the upstream structure basin has significant sand deposits and willow growth. Upstream of the third structure, knickpoints are present at several locations. The right bank is eroding and consideration should be given to fencing the right bank upstream of the third structure to limit cattle access. Consideration of some form of grade control should be made at the upstream extent of Segment 4.

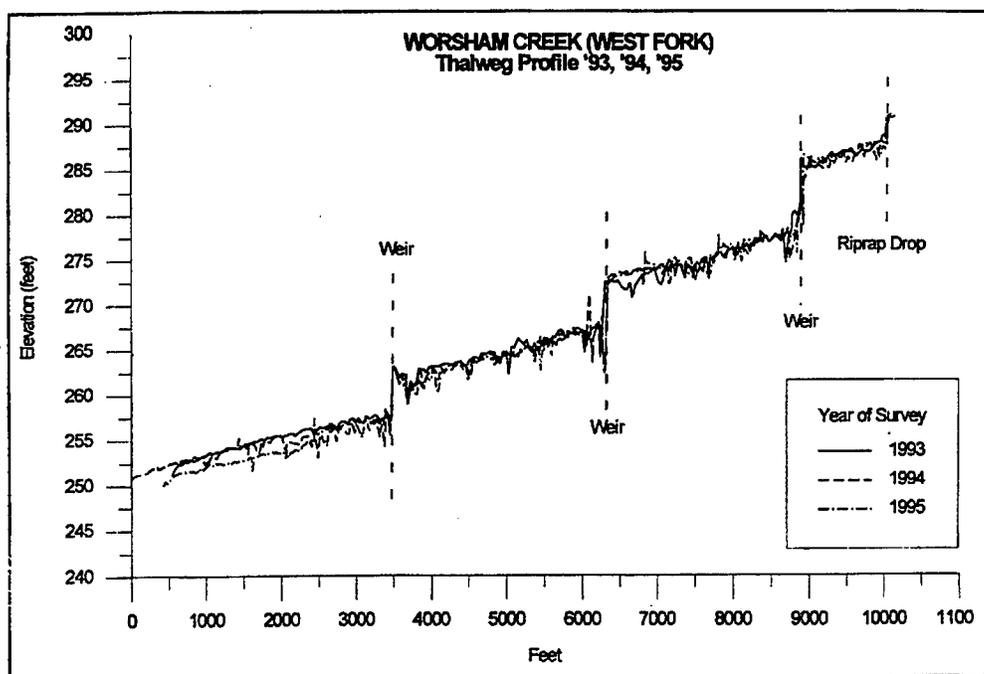
Figure 53. Thalweg profiles for West Worsham Creek, site 18c

The total reach length is approximately 10,000 feet and is divided into four segments by three ARS-type low drop structures. See Table 24 for summary results and Figure 53 for thalweg profiles. The accompanying thalweg profile, Figure 53, indicates continuing degradation in the lower segment, and clearly indicates the aggradation immediately upstream of the second structure. Note that the 1995 profile indicates filling to the weir crest of the second structure, while the older, first structure has not filled. This indicates that the improved hydraulic control of the newer design results in improved performance, and suggests that renovation to improve hydraulic control is worth consideration.

The table of BURBANK results indicates that banks are relatively stable, except in the lower segment. This was confirmed by field inspection in November, 1995. Continued degradation will exacerbate Segment 1 bank stability. Consideration should be given to construction of grade control in the segment.

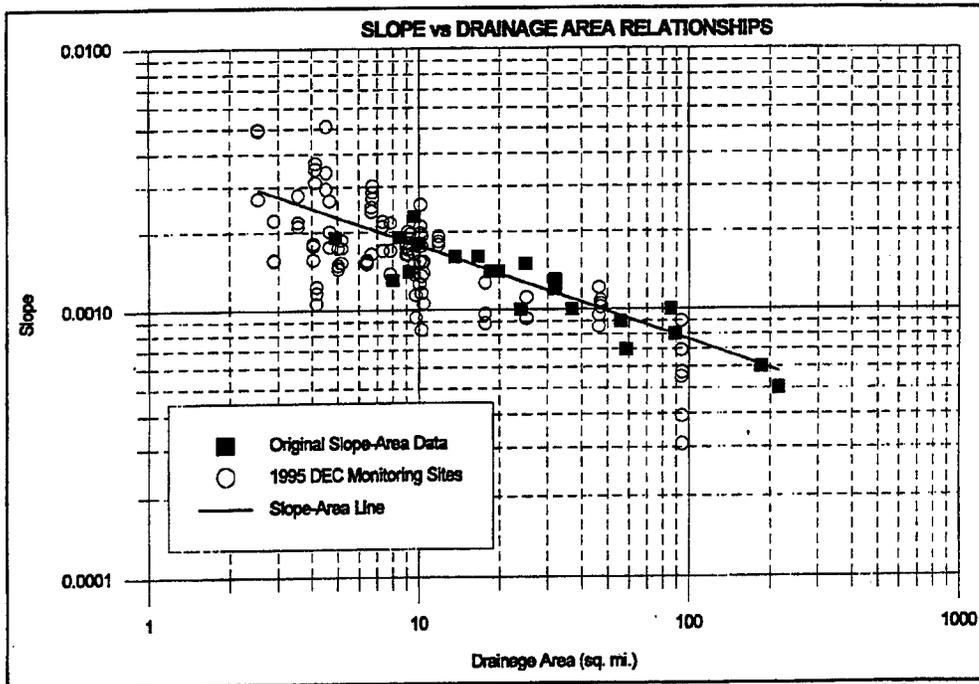
Figure 54. Slope vs drainage area relationship

of stable channel reaches. Figure 54 depicts the original data, the regression of the original data, and data from the 1995 DEC monitoring reaches. Stability was generally defined in terms of the Channel Evolution Model (CEM) (Schumm, et al., 1984). Regression of the original data used in GDM No. 54 results in the following relationship:

One factor to consider is that drainage areas for the DEC monitoring reaches are generally smaller than the original-data drainage areas. As shown in Figure 54, only one reach less than 8 square miles was included, whereas, the DEC monitoring reaches are primarily in the range of 2 to 10 square miles. Figure 55 is a comparison of the DEC monitoring reach energy slope data shown as CEM types, and the GDM No. 54 slope-area curve. For the portion of the slope-area curve greater than 10 square miles, most of the reaches are CEM 4 or CEM 5, indicating a reasonable degree of stability. For drainage areas less than 10 square miles, the slope-area curve is defined by CEM 2 or CEM 3, generally unstable reaches. The CEM 4 less than 10 square miles in drainage area are below the relationship.

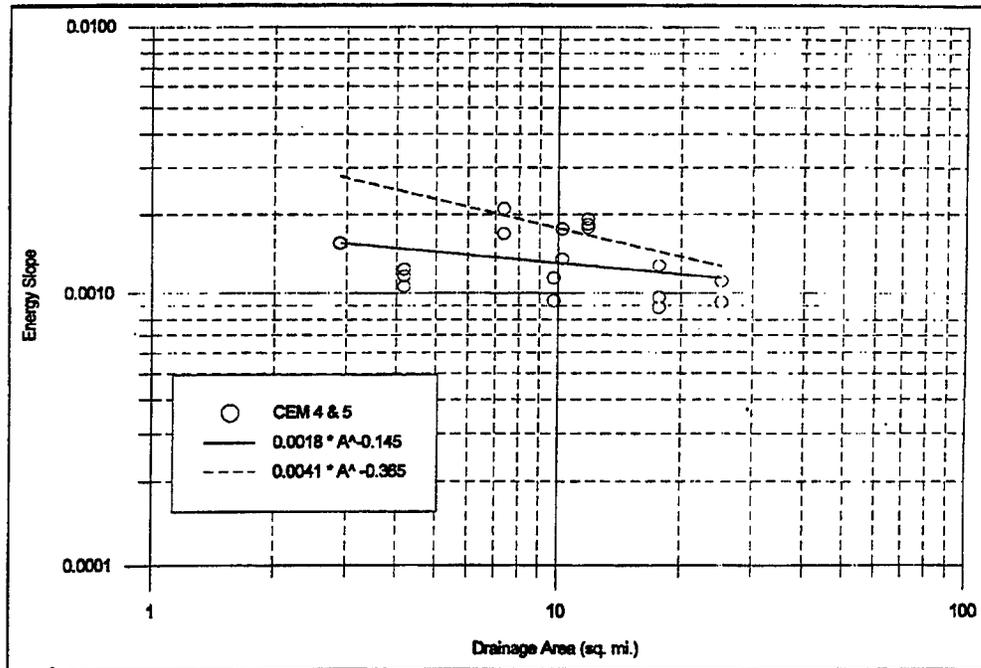
Figure 56. 1995 CEM data with two regressions

Figure 56 is similar to Figure 54, with the following exceptions: a.) 1995 DEC monitoring reach data for only CEM 4 and CEM 5 reaches are plotted; and b.) these data exclude reaches that are ponded because ponding was not included in the original conception of the CEM. A new regression was made of the plotted data and the following relationship was plotted using a solid line (Figure 56):

using the same parameters as previously noted. The GED No. 54 relationship is shown above as the dash line. One of the primary reasons for lowering the relationship is that

the sediment supply to the reaches has been reduced by the numerous drop pipes, land use improvements, and bank stabilization measures that have been employed by the DEC programs. Stability, as defined by the CEM criteria, includes a balance between sediment supply and sediment transport capacity. As the sediment supply has been reduced, the stable slope must also be reduced. Therefore, although the slope-area curve is a useful benchmark for comparison of reaches, the curve will require updating as success occurs in reducing sediment supply. The new relationship has a statistically poor fit; however, it demonstrates that the slope-area relationship must be re-evaluated. Consideration should be given to using design procedures that explicitly include sediment supply and transport capacity.

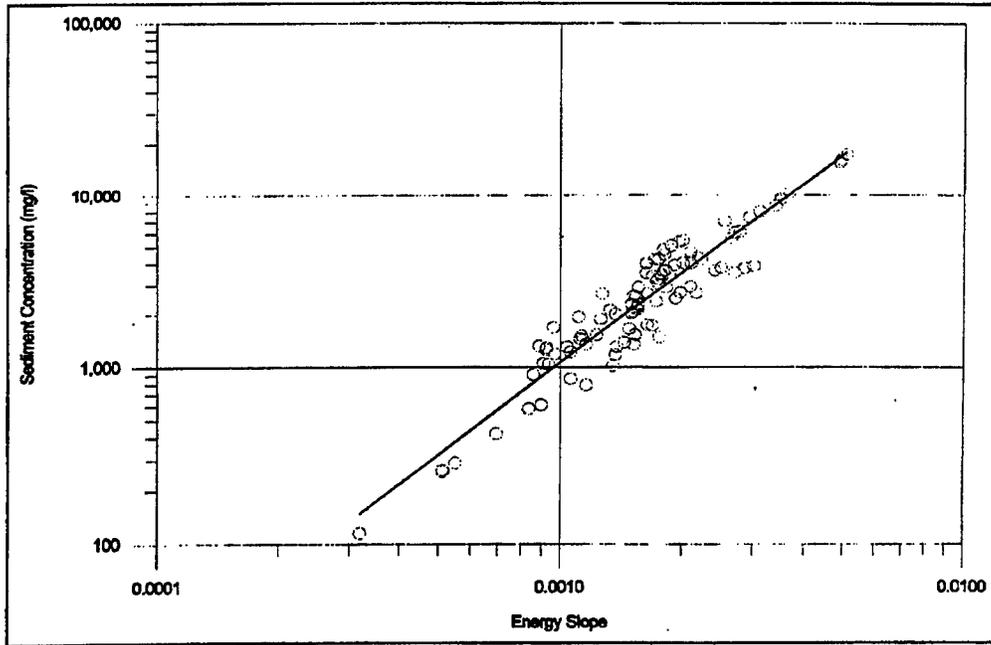
Figure 57. Relationship between energy slope and computed sediment concentration For DEC monitoring reaches

Unfortunately the slope-area regional stability curve, although useful, does not explicitly include sediment yield or sediment transport capacity. The relationships only implicitly include the sediment yield of the stable channels used in the data base. Figure 57 depicts the relationship between the energy slope and the computed sediment concentration in the DEC monitoring reaches. A regression expression for the data is:

with the units of concentration as mg/l, and  $S$  is the energy slope. The coefficient of determination ( $R^2$ ) is 0.89. As shown in Figure 4.4, the sediment concentration for  $S = 0.0009$  is approximately 1000 mg/l, for  $S = 0.004$  the concentration is approximately 10,000 mg/l. Figure 4.5 shows the slope-area curve from GDM No. 54, and has values of sediment concentration taken from Figure 4.4 for selected drainage areas. Therefore, using the slope-area curve for stable channel design would require the designer to accept 712 mg/l at 90 square miles, 2849 mg/l at 10 square miles, and extrapolating the relationship, 7170 mg/l at 2 square miles.

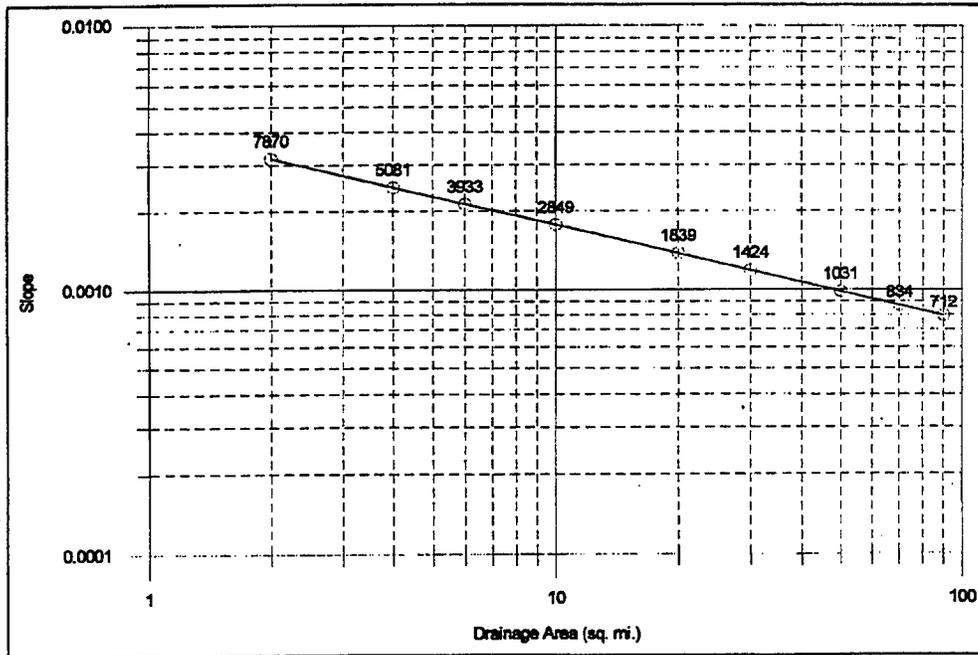
Figure 58. Sediment concentration for the 2-year discharge along the GDM No. 54 slope-area curve

The consequence of designing grade control using the GDM No. 54 slope-area curve, when considered in a sediment transport frame of reference, can be examined in a general sense using data from the DEC monitoring reaches. The average sediment transport capacity expressed as a concentration for all of the DEC monitoring reaches at the 2-year discharge is 3428 mg/l. The average drainage area for the DEC monitoring reach segments with grade control is 7.4 square miles, and from Figure 4.5 the average sediment concentration is 3446 mg/l using the GDM No. 54 slope-area curve. Therefore, reaches that include grade control structures designed using the GDM No. 54 slope-area curve may reduce sediment concentration in those reaches, however, the reaches would continue to contribute sediment at the same or greater concentration as compared to the present overall average concentration. A new procedure should be considered to enable design for reduction of sediment yield.

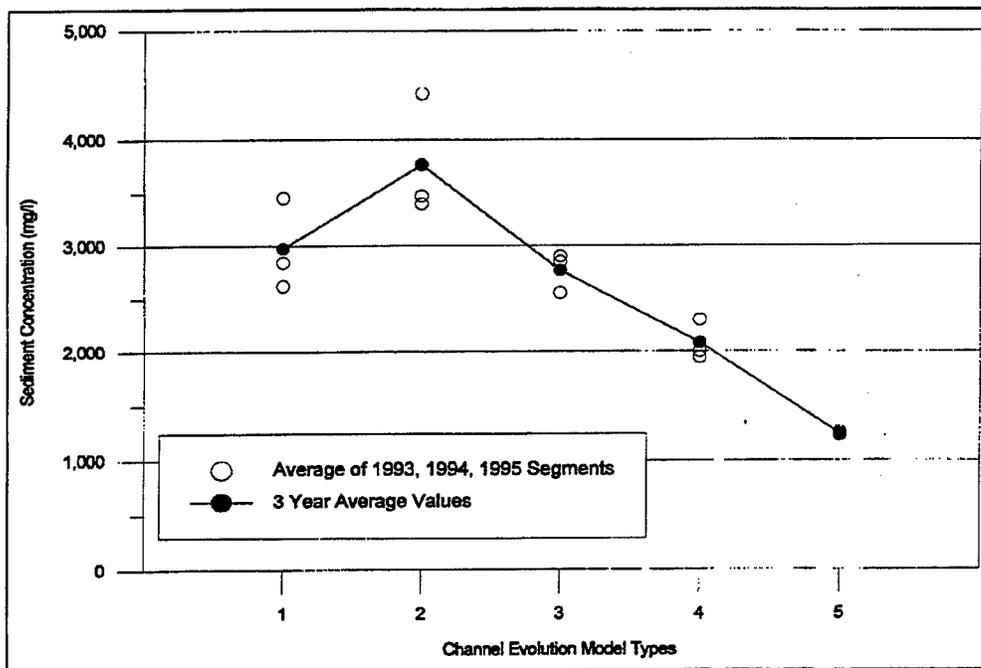
Figure 59. Computed sediment concentration for CEM types

The proposed structure location procedure would be to select an energy slope based on the desired sediment transport concentration. The sediment transport concentration of the CEM 5 reaches within the DEC monitoring reaches can be used to select a design slope. Figure 59 provides a summary of the sediment concentration for CEM types for 1993, 1994 and 1995; the line through the data is the average for each CEM type. Figure 4.4 can be used to estimate the energy slope. The data indicates the design slope for the CEM 5 concentration of 1000 mg/l would be approximately 0.001, and the CEM 4 concentration of 2000 mg/l would be 0.0014. Structures could be located using this range of bed slopes, which would reduce sediment concentration below the existing average sediment transport. A check could then be made comparing bed slope and energy slope, and adjustments could be made if required.
